SPRINGWOOD WATERWAY
APRIL & MAY 2014 - LAKE BIOASSESSMENT

On **April 8th, 2014**, Seminole County Lake Management Program (SCLMP) staff, Thomas Calhoun and Joey Cordell, surveyed the aquatic plants of **Springwood Waterway**.

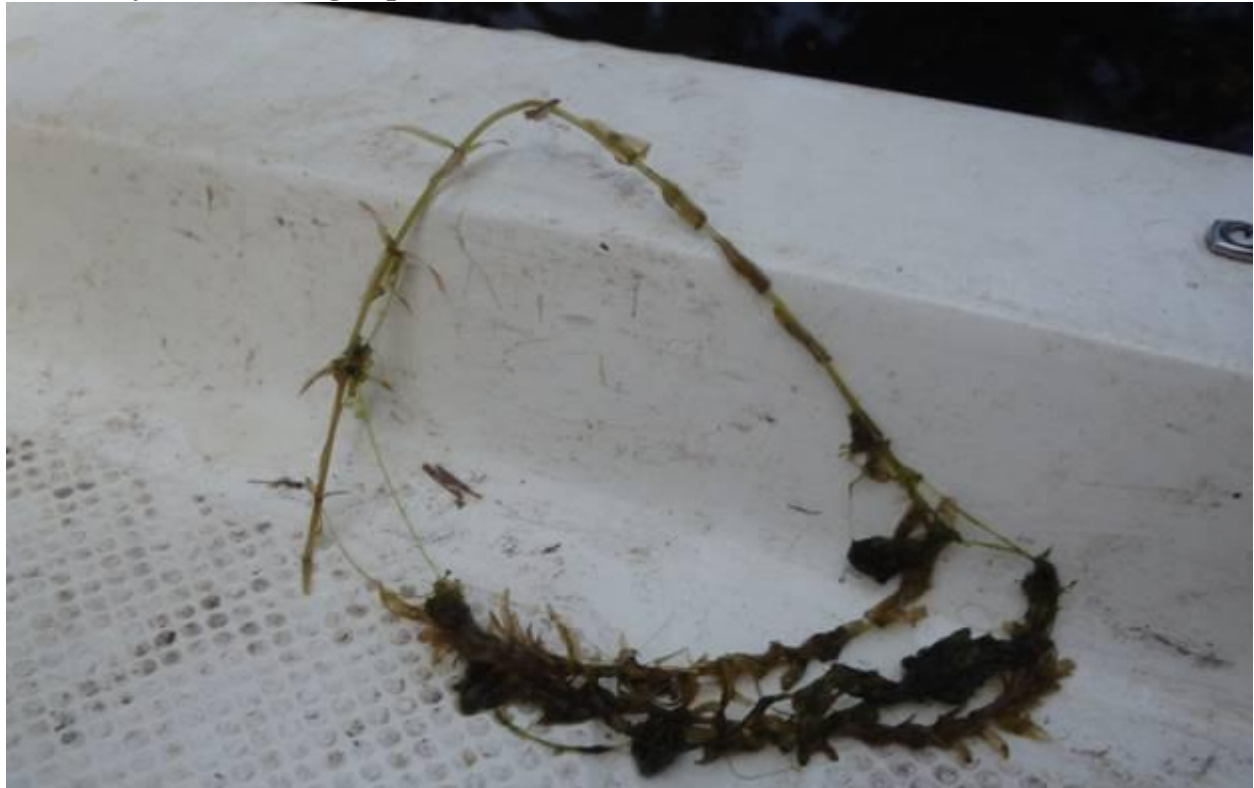
Treatment for hydrilla was conducted Thursday, March 20th in the back half of the waterway. During the inspection hydrilla was showing signs of impact from the treatment. We will continue to monitor hydrilla to see if any further actions will be necessary. The waterway was observed open and navigable therefore mechanical harvesting is not needed at this time.

Photo: Hydrilla showing impacts of treatment.

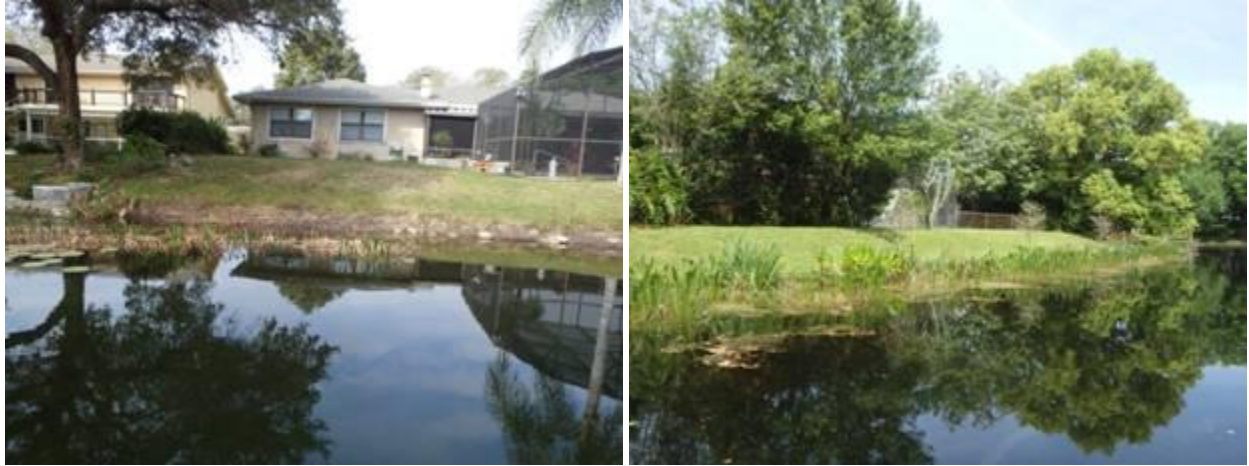
Native emergent vegetation is doing very well throughout the waterway and is recovering/expanding from the “winter die back”. Sites from the June 29th restoration event have established and are beginning to expand very nicely. Kudos to all who have made this so successful!

Photo: Pickerelweed showing “winter die back” (left). Recovered/expanding vegetation (right).

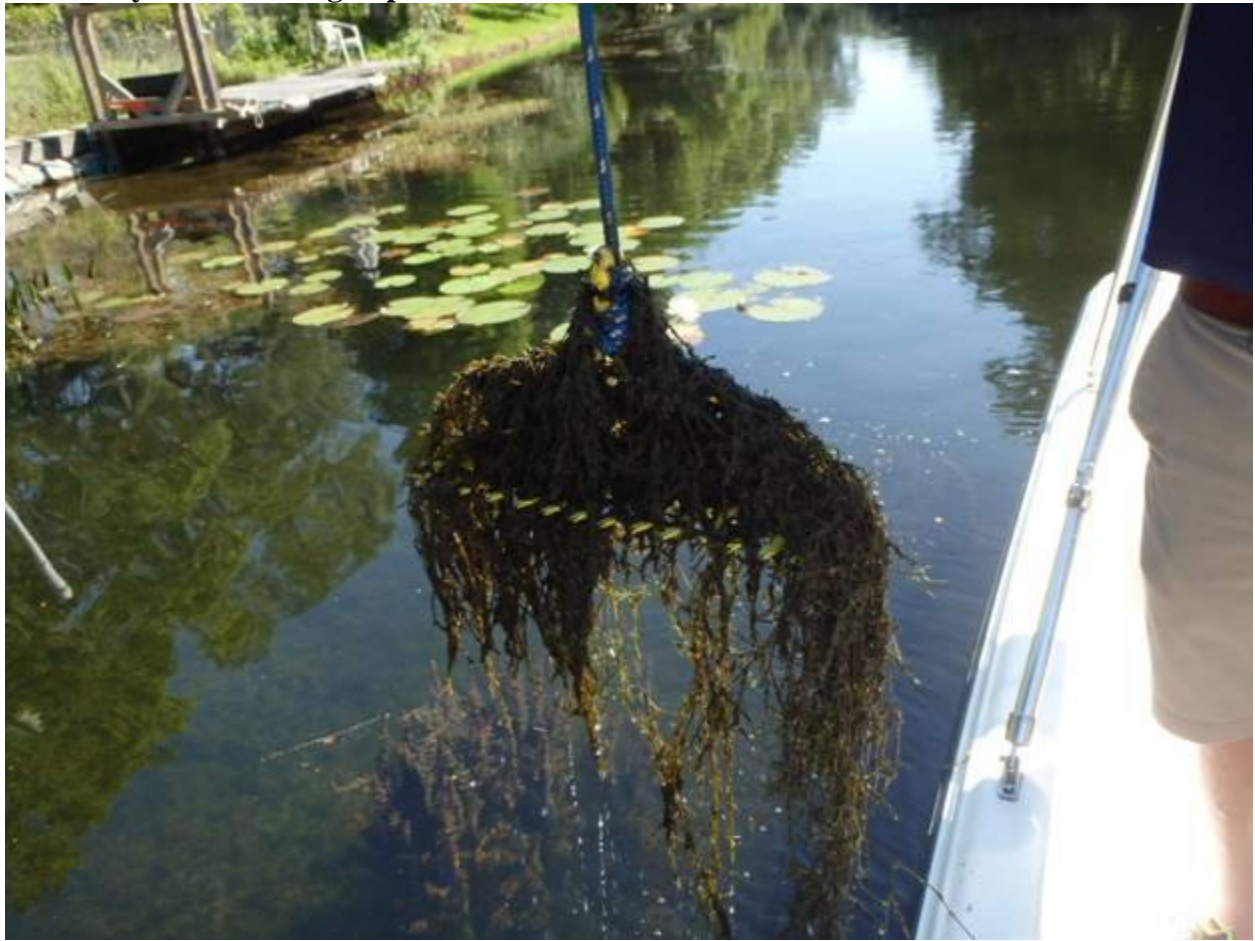
Treatment for hydrilla was conducted Thursday, March 20th in the back half of the waterway. All hydrilla found during this inspection was heavily impacted by the treatment and is anticipated to die. We will continue to monitor hydrilla to see if any further actions will be necessary.

Photo: Hydrilla showing impacts of treatment.

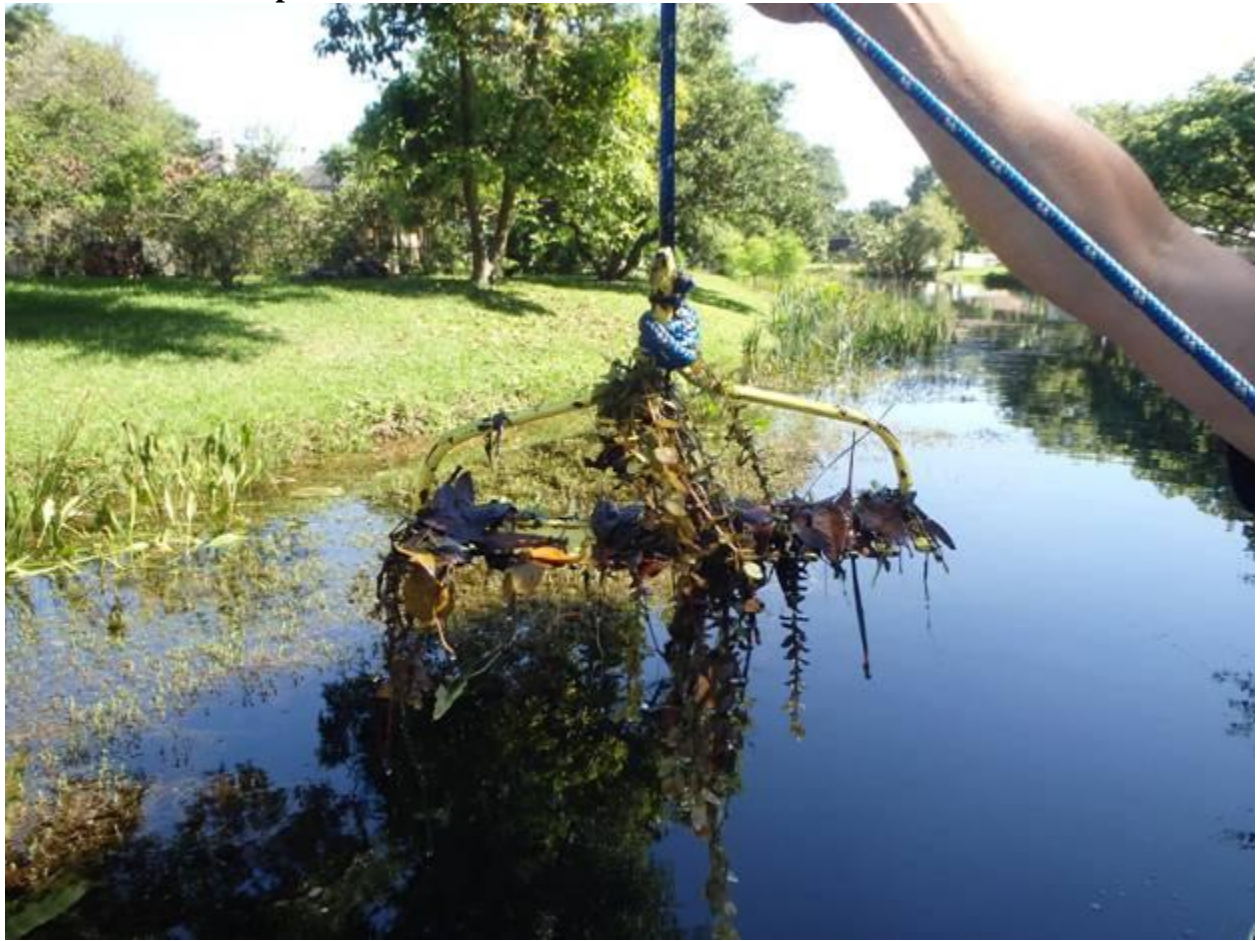
Native SAV is expanding in the waterway. These species includes lemon bacopa, stonewort, and bladderwort. Lemon bacopa has expanded along the majority of the banks within the waterway and is reaching the surface in many areas. The waterway was observed open and navigable therefore mechanical harvesting is not needed at this time.

Photo: Lemon bacopa.

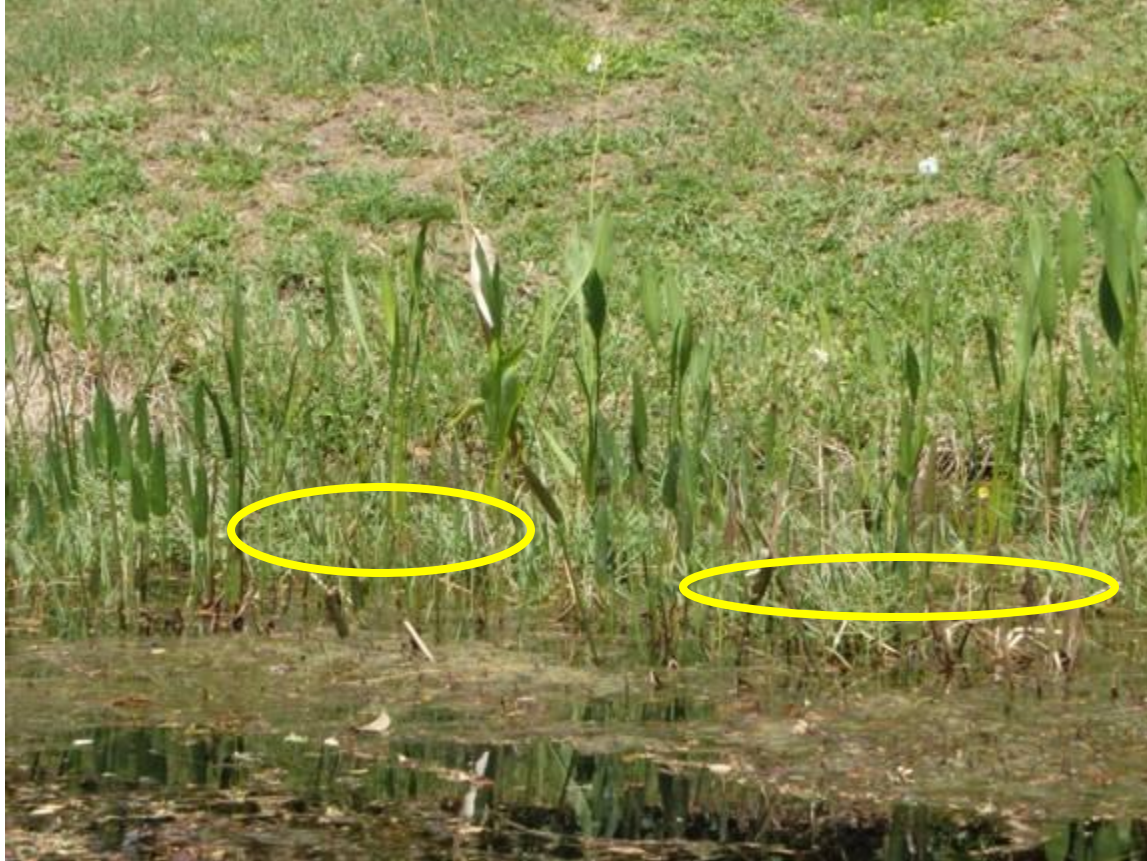
Photo: Example of torpedo grass (highlighted) mixed in with duck potato.

Native emergent vegetation continues to be found in many locations, in good condition, and expanding! The exotic vegetation, such as torpedo grass, alligator weed and elephant ear, will continue to be targeted by the MSBU funded herbicide contractor. As native emergent plants expand, we recommend hand removing any torpedo grass that is found mixed within.
